Mobile Intel® Pentium® 4 Processor-M

Specification Update

December 2004

Document Number: **250721-028**

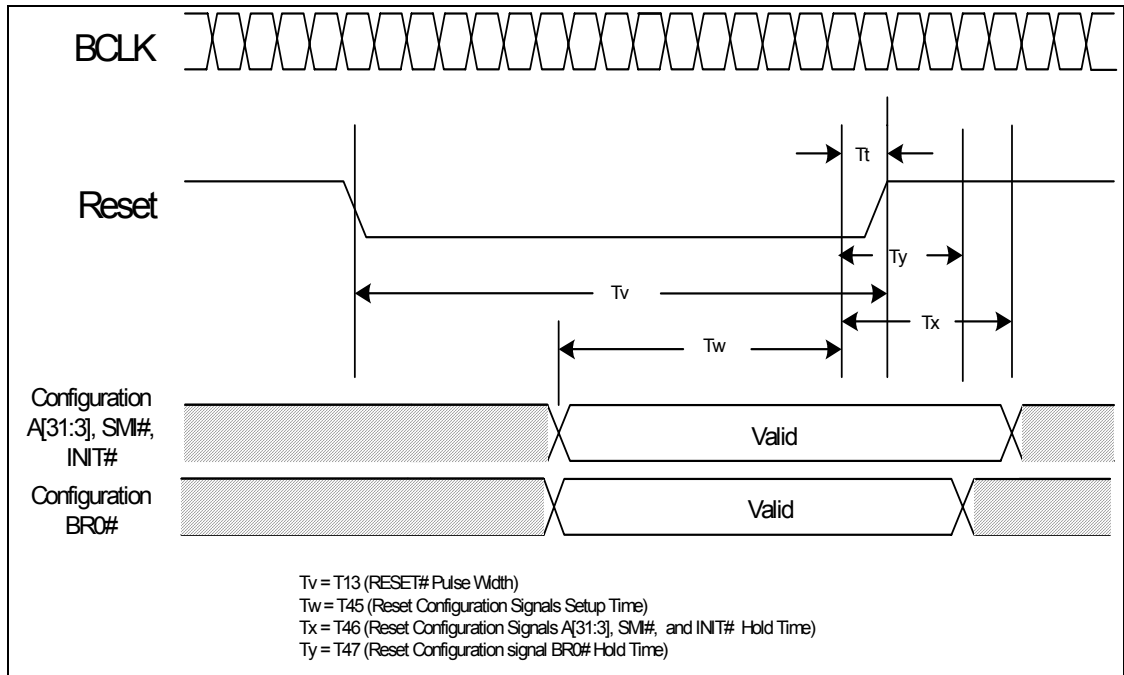
Figure 13. System Bus Reset and Configuration Timings

The BR0# maximum hold time has changed to 2 BCLKs. This change will be shown in the “System Bus AC Specifications (Reset Conditions)” table and “System Bus Reset and Configuration Timings” figure of the *Mobile Intel® Pentium® 4 Processor - M Datasheet*. This change will be incorporated in the next revision of the datasheet.
