# Intel<sup>®</sup> 82801CAM I/O Controller Hub 3 (ICH3-M)

Specification Update

*February 2004*

Document Number: 290718-007

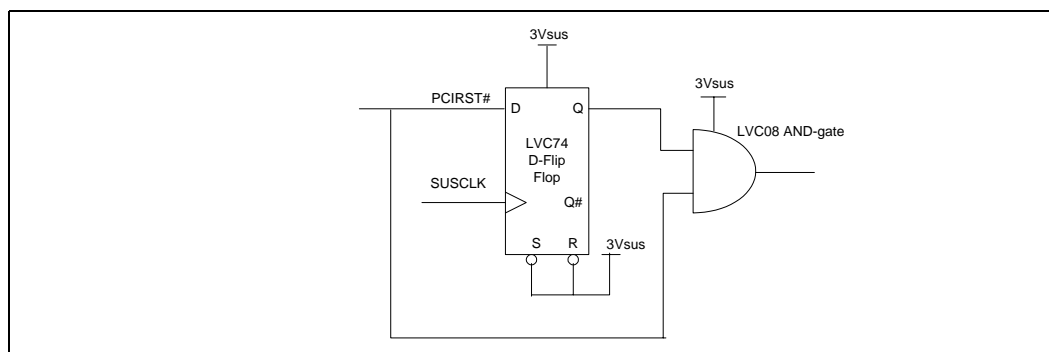
**Problem:** The ICH3-M specified 1–3 RTC timing of SUS\_STAT# inactive to PCIRST# inactive violates the LPC specification of “at least 60  $\mu$ s.”

**Implication:** Some LPC devices may not properly reset resulting in failure of the system to boot or resume from a sleep state.

1. Delay PCIRST# by 1 SUSCLK using a D-flop and an AND gate to the LPC devices.
